UPPER WILLIAMSON RIVER WATERSHED ANALYSIS DOCUMENT

Chiloquin and Chemult Ranger Districts

Winema National Forest

August, 1996

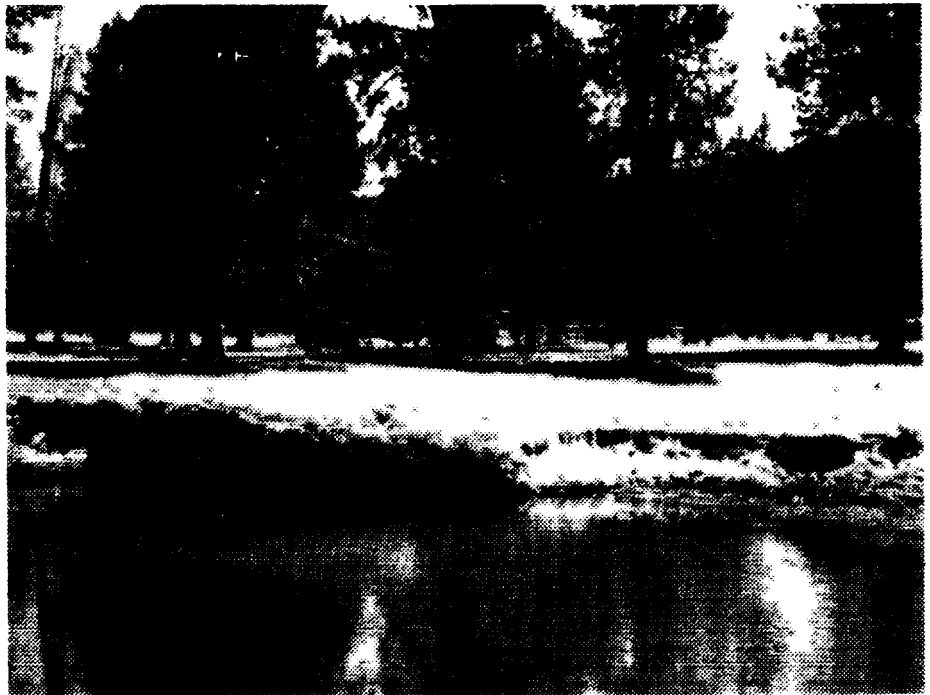
Actively eroding channel banks at Rocky Ford, aggravated by past intense grazing pressure.

The Williamson River appears to have downcut 4 to 5 feet into its valley from below a natural reef near the mouth of Sand Creek, all the way to the Klamath Marsh. The entrenchment is most noticeable below Rocky Ford. It is speculated that the primary driver for this downcutting has been a lowering of the level of the Klamath Marsh over the past 100 years. Heavy use of the river valley and bank area by domestic livestock has contributed to accelerated erosion rates. This erosion appears to contribute to the lateral migration of the channel, more than the continued downcutting. The current river condition below Sand Creek is intermittently unstable. The river bank is very active in many segments, supplying significant amounts of

sediment to the channel on an annual basis. Stream banks are often lacking stabilizing vegetation, and are likely to remain subject to accelerated erosion rates for many years to come.

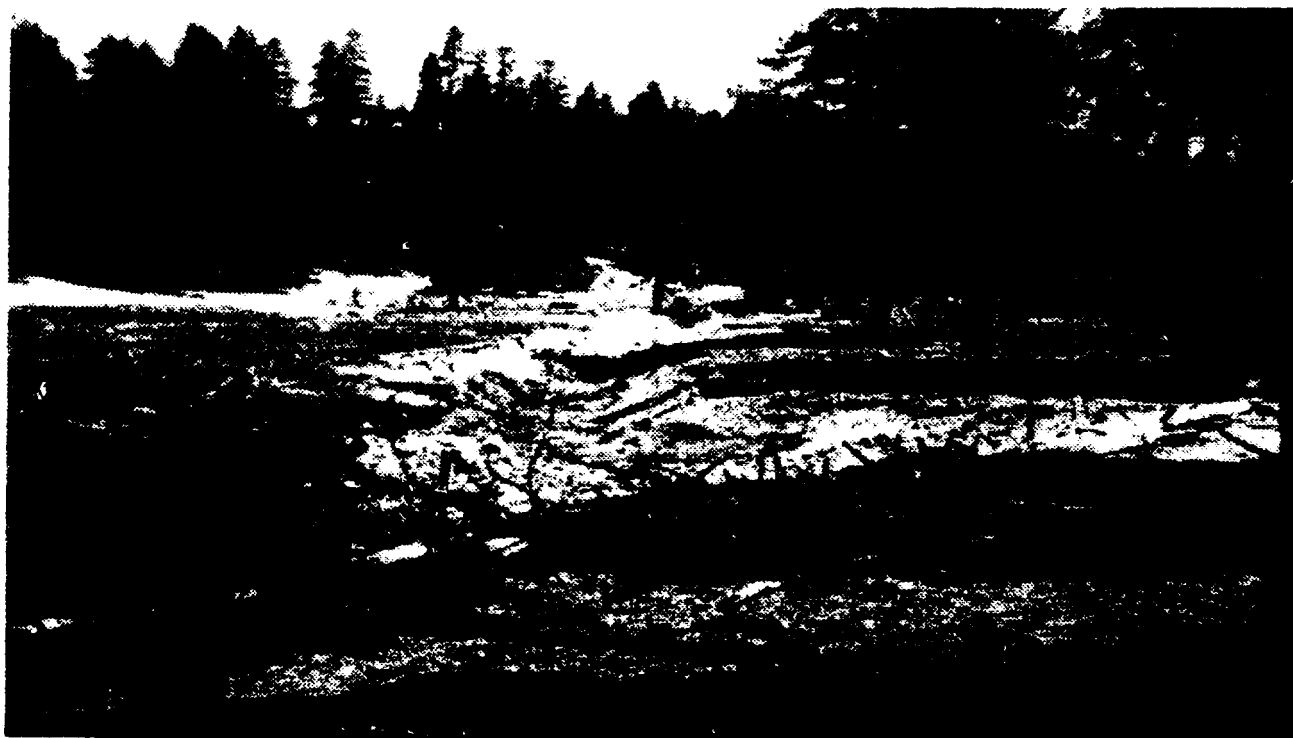
Bull Pasture Watershed Improvement Project. Lodgepole pine placed along creek bank to keep cattle from further breaking down channel bank.

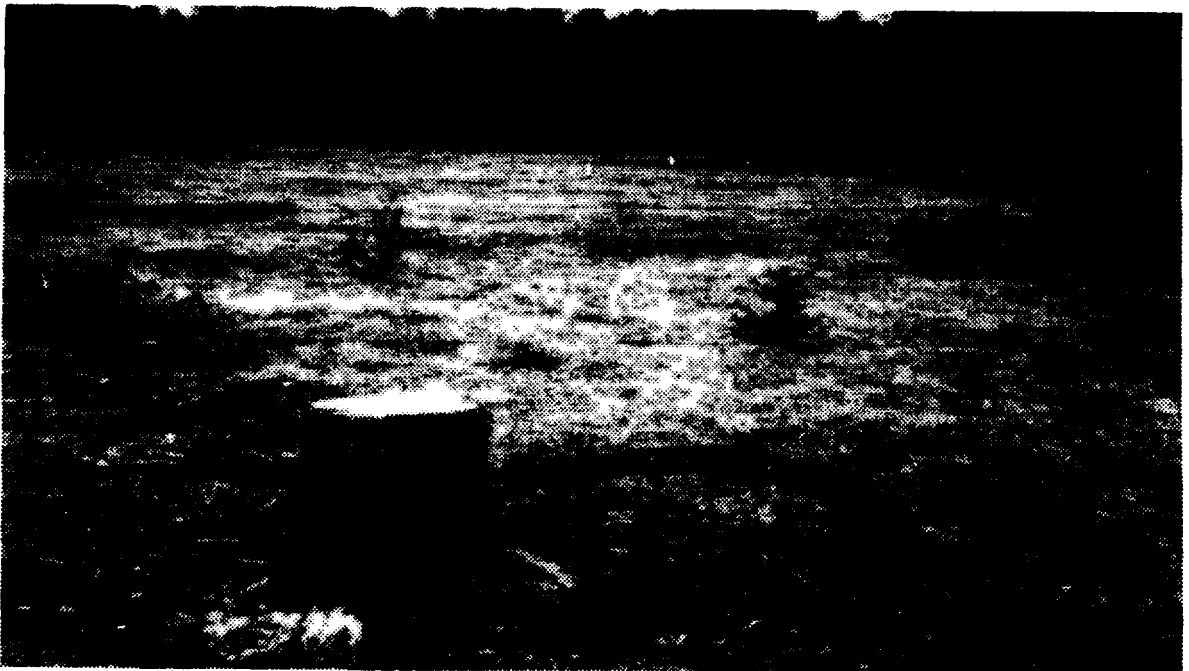
Results of firewood cutting in Haystack Draw meadow.

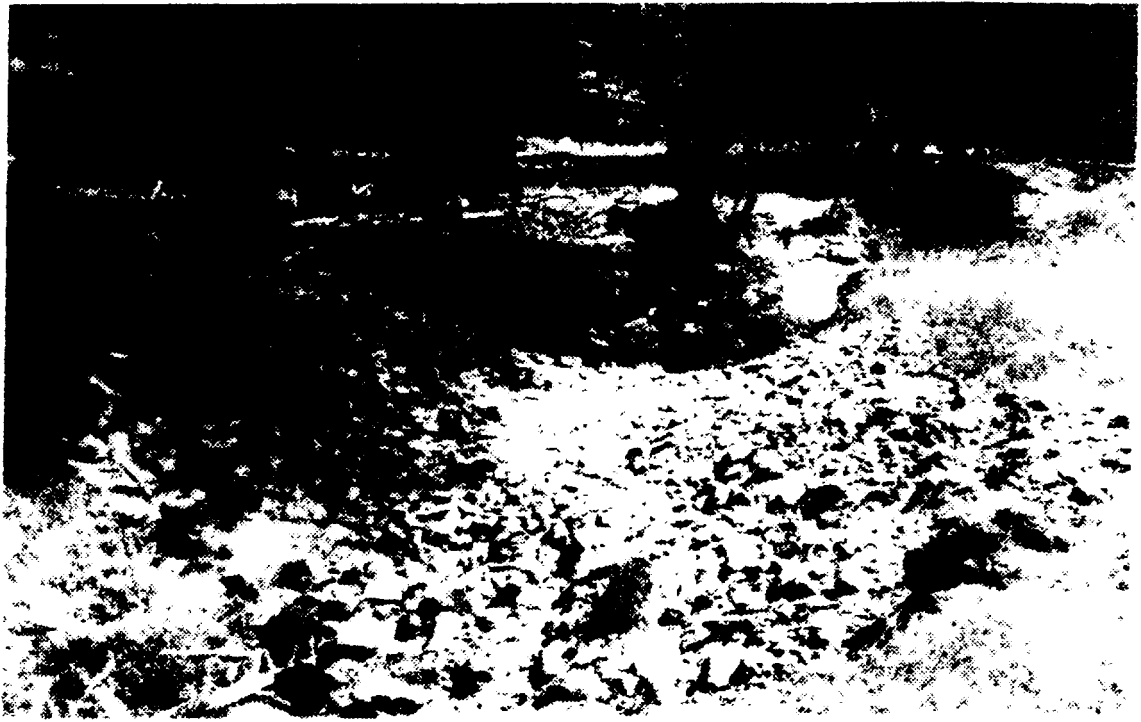
1989 Watershed Improvement Project to correct headcut in Telephone Draw.

The unstable channel segments in Telephone Draw, Haystack Draw, and the Bull Pasture appear to be improving after several years without livestock grazing and after placement of erosion control structures in the more critical areas. Continued use of the meadows in these areas as vehicle access for firewood cutting place them at risk of additional channel degradation. The Williamson River between the Sand Creek reef and the Klamath Marsh has many actively eroding channel banks. The current channel does not appear to be downcutting as much as moving laterally within its valley. The heavy sediment loads from the actively eroding banks is more than the channel can handle in some reaches, making the channel wide and shallow. A slow recovery process has begun in segments where annual grazing use has ceased. Unstable conditions persist in segments where annual disturbance continues. (See Appendix C for further information on channel conditions.)

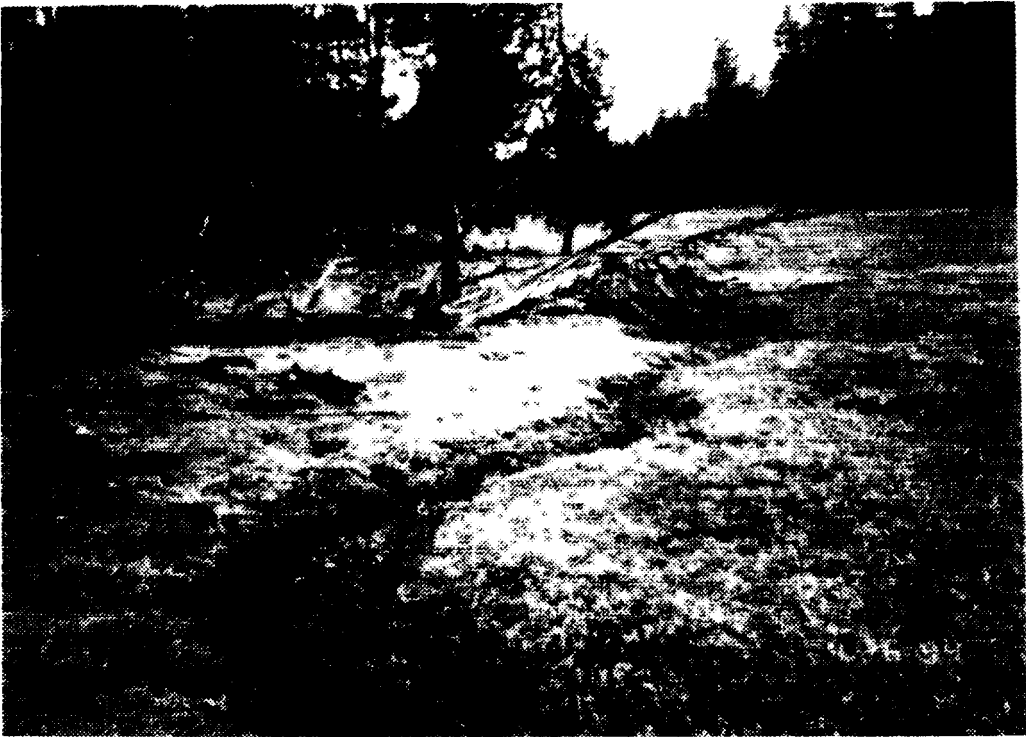
Erosion gully created by cattle trail in the Bull Pasture system.

Grazing is not the sole factor in modifying channel conditions. Heavy grazing activities along with extended drought conditions make the meadow environments and the natural channels of the study area more susceptible to above normal or high intensity runoff events. Heavy runoff events along with sparse

vegetative cover and weakened root mass accelerate erosion rates and destabilize the channels. This condition is then aggravated by continued grazing pressure.

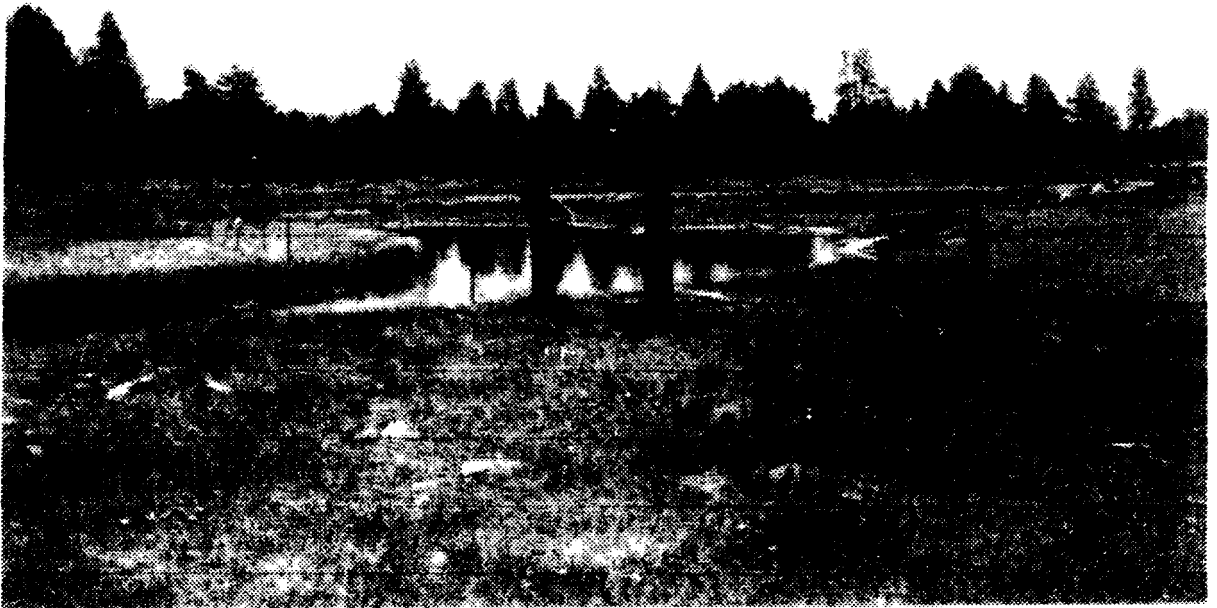
Long term effects of past cattle grazing on the current Yamsi Allotment near Sand Creek Ranch.

The major example in the study area is the Williamson River. Below the confluence with Sand Creek, the river banks are generally devoid of the natural stabilizing vegetation (Willow), the channel is relatively wide and shallow, and the channel banks are aggressively eroding every year during high flows. Flood flows no longer have access to the valley floor to dissipate energy and control erosion rates. Continued use of the river banks by domestic livestock tends to maintain this unstable condition, adding to the already abnormally high sediment loads. The initial cause of channel destabilization was likely the downcutting of the main channel, when the water level of the Klamath Marsh lowered near the turn of the century. Continuous grazing use has retarded the recovery of the channel form to a more stable condition.

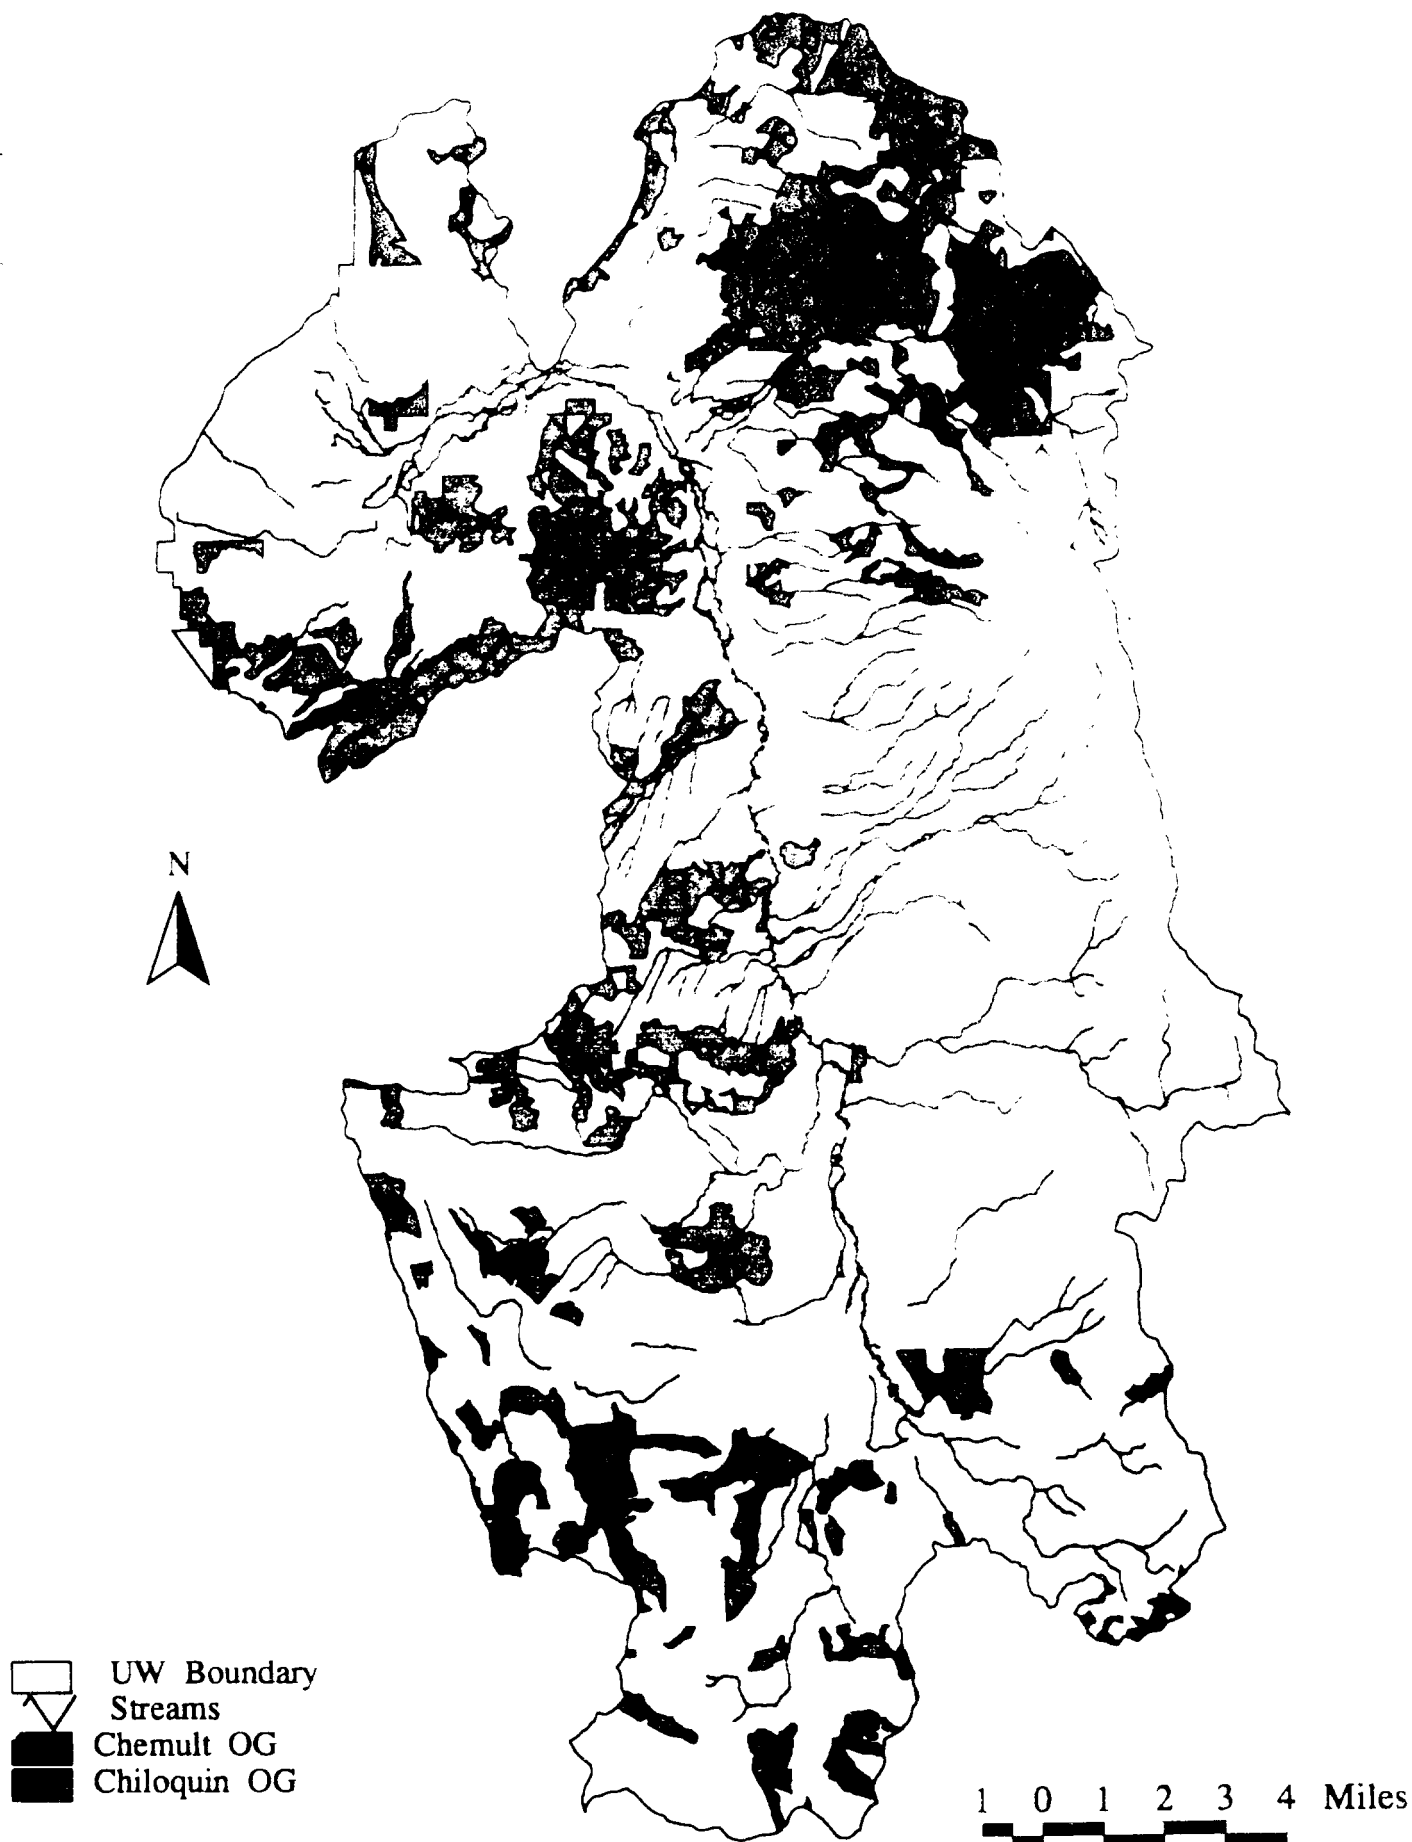
Inventoried Old Growth

Comparing the *Inventoried Old Growth* and *Harvest Areas* maps on the following pages shows that in general, past harvests have not resulted in elimination of those areas from old growth classification.

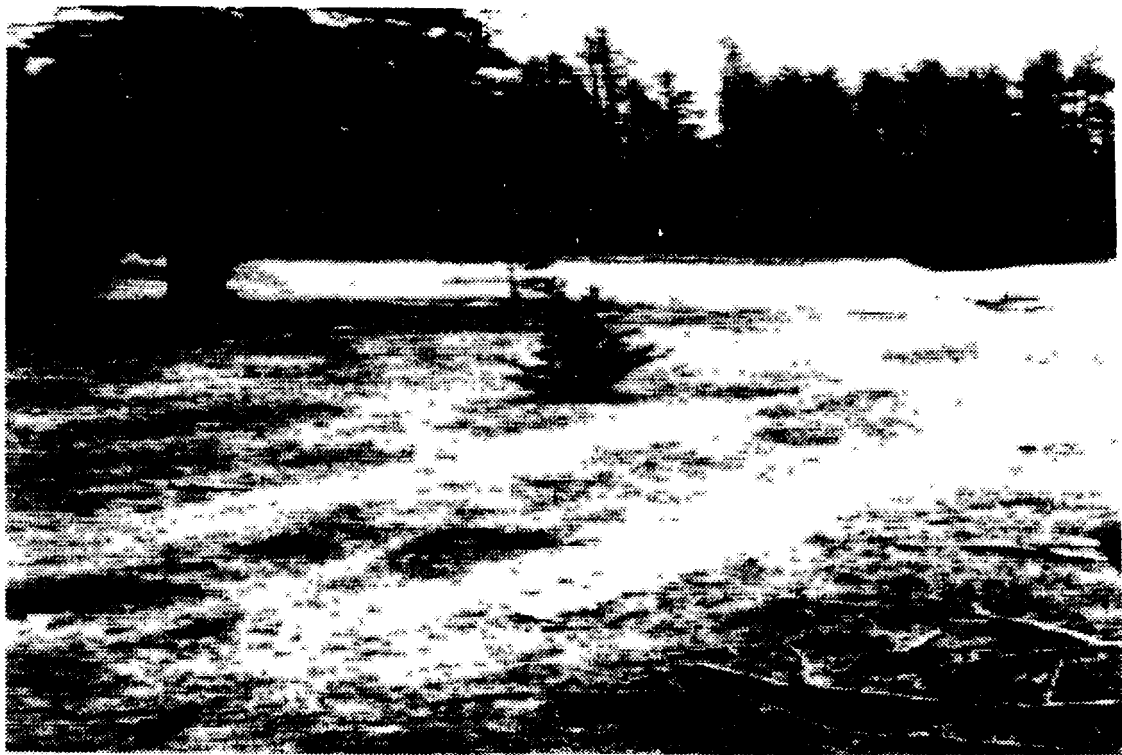
Haystack Draw meadow, typical of increased vehicle traffic in riparian areas.

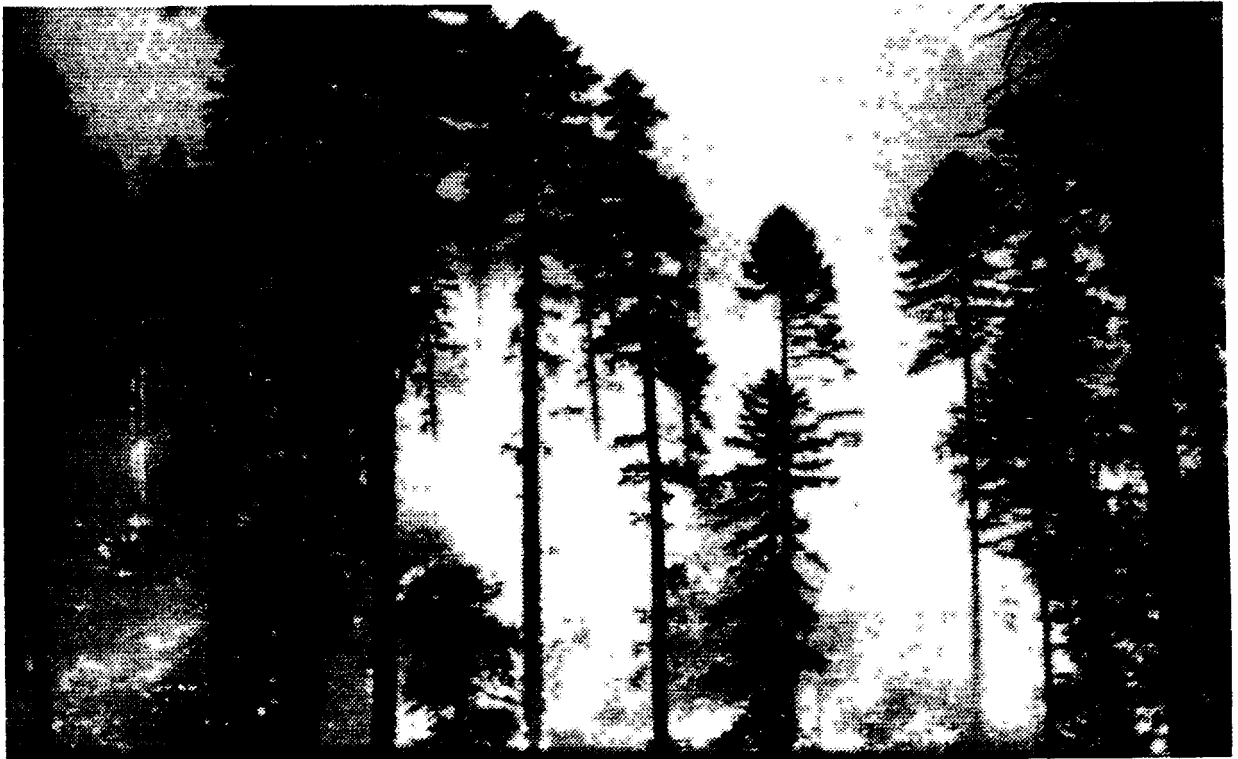
Note the involved boles of many of the trees, causing mortality even though the fire is not extremely intense.

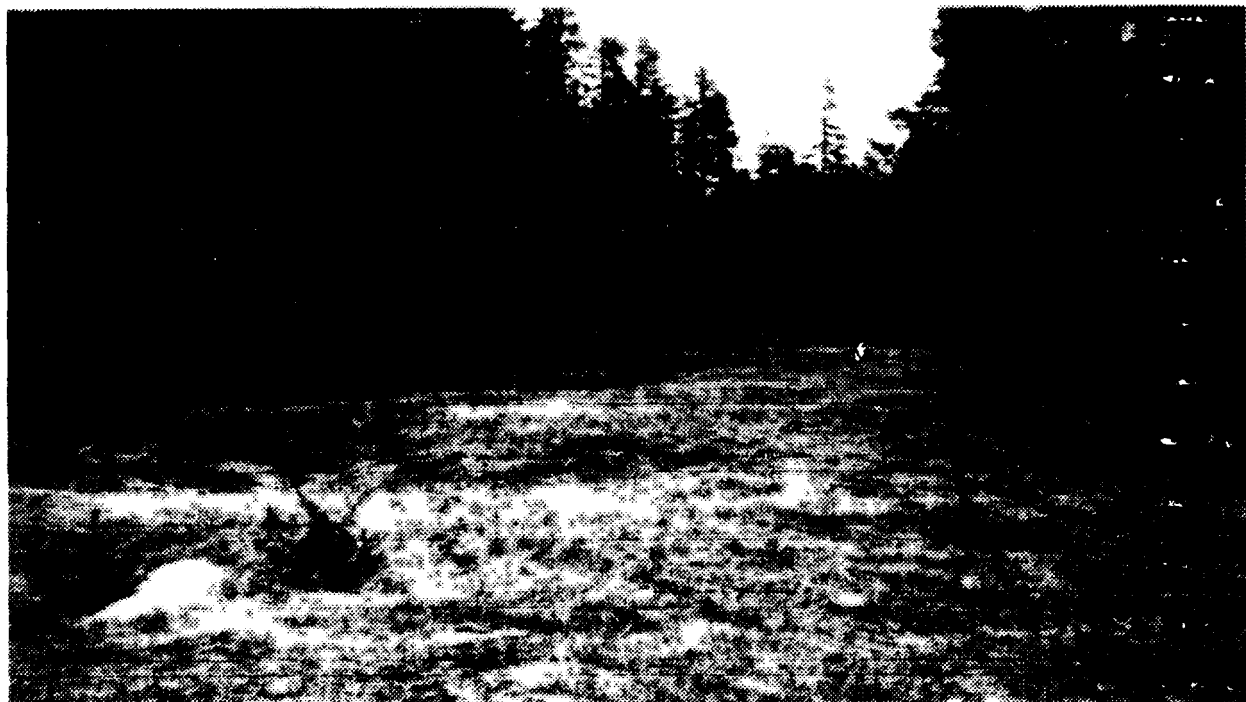
Photo showing a common occurrence within the analysis area; conifer encroachment into a meadow type community.

Elk population increases within the analysis area are in a large part due to the extensive removal of timber during the late 1970's through the 1980's on both private and public lands. This allowed early successional forage to increase (primarily dryland grasses). Further population increases may be related to decreases in livestock numbers, grazing intensity, and acres grazed on both public and private lands (See maps showing Historic Active BIA Allotments and Current Active FS Allotments on next pages). Some of the early successional forage areas created in the 1970's and early 1980's, are now converting more to a cover type than a forage type. Livestock use has decreased allowing elk use of meadows to increase. Some forage production in meadows may be lost due to conifer encroachment. Also, some of the early successional forage areas created in the 1970's and early 1980's, are now converting more to a cover type than a forage type community.

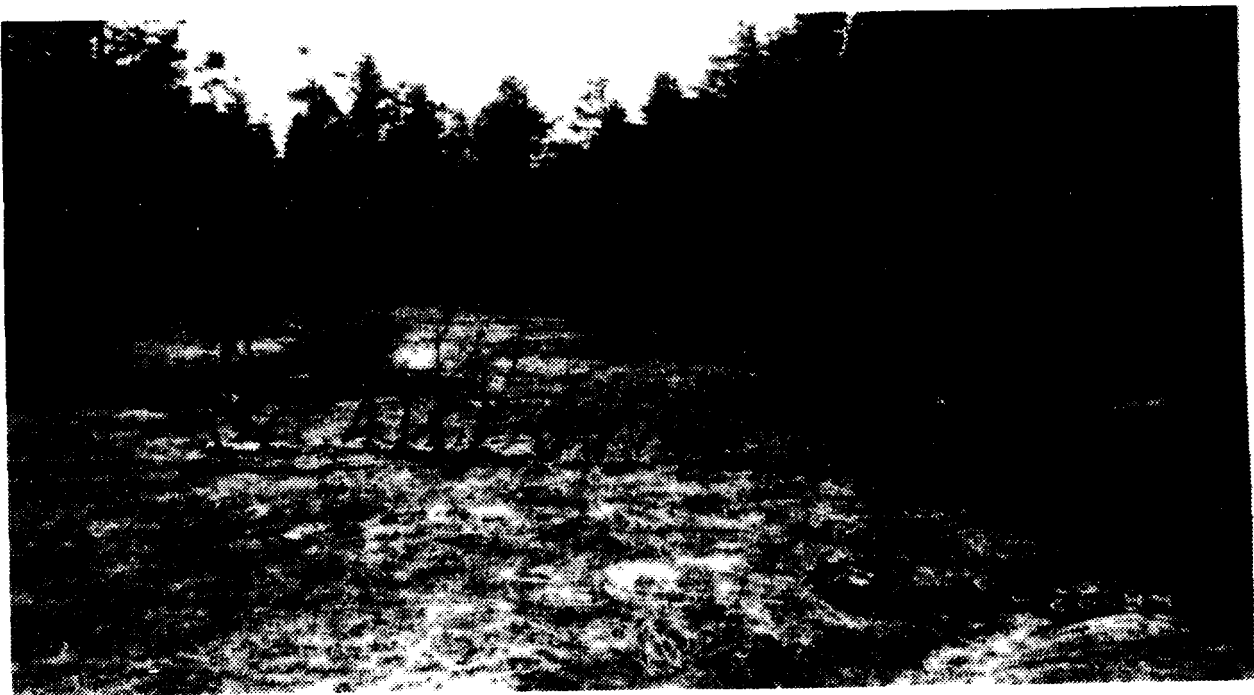
Lodgepole encroachment and decadent willows in Telephone Draw, both signs of an unnatural fire interval. Note the browse line on willows.

Fire suppression has allowed development of forage base (bitterbrush), but reduced upland grasses and forbs. Presently, continued suppression has resulted in the decline of the forage base [lodgepole
